Morrone Home Inspection

Property Address 7272 Chicago Way
Chicago, IL 60678
Approximate Year Built 1948
Approximate Square Footage 1,963
Number of Bedroom - Bath 3 Bedrooms
2 Bathrooms
Direction House Faces South

Inspection Date 7/8/2022
Inspection Start - End Time 10:00 am - 12:00 pm
Weather Conditions Recently rained
Outside Temperature 85 Degrees
Price for Inspection(s) \$350.00
Inspector Name
Giovanni Morrone
License Number
450010494

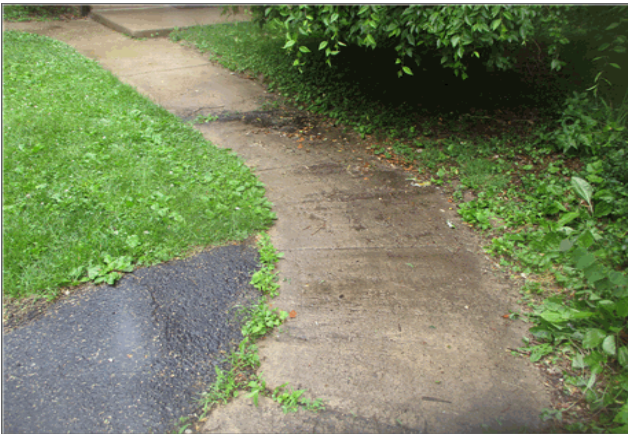
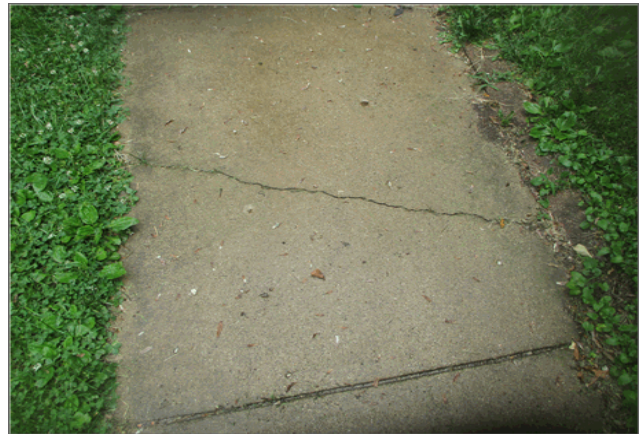
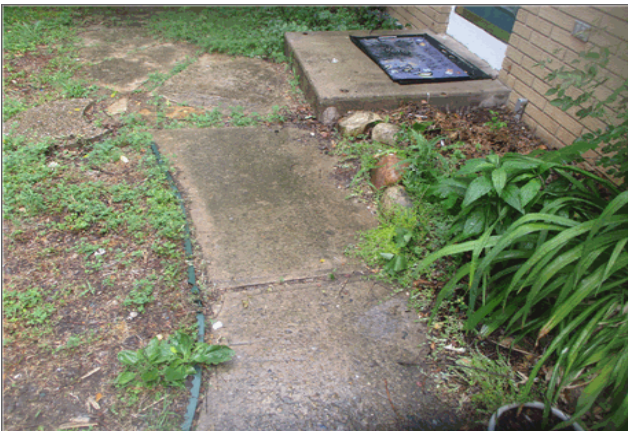
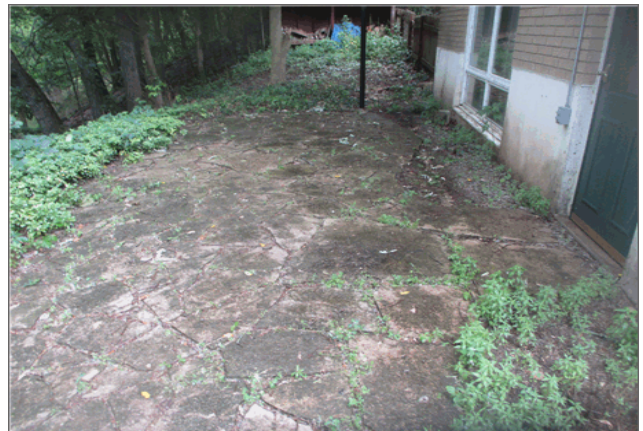
1.2.2 Driveway - Sidewalk Conditions

Asphalt on driveway has wear, and seal coat fading throughout driveway. Concrete sidewalks has settlement cracking. Recommend to repair, or replace.

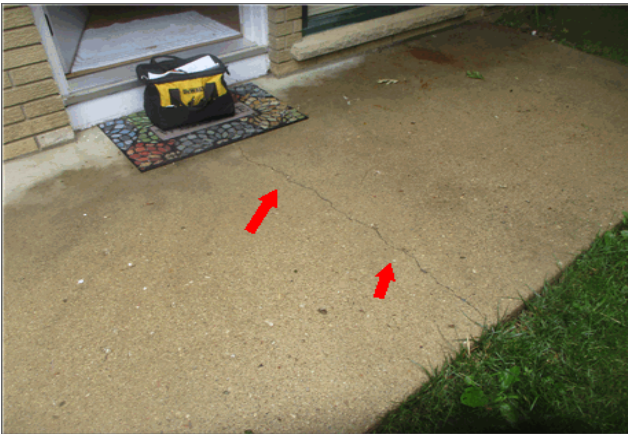
2.1.2 Front Entrance Conditions

Settlement crack is present to concrete landing on front porch. Recommend to repair, or replace.

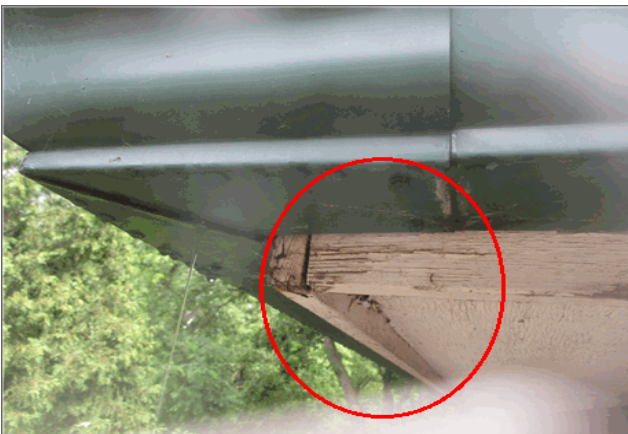
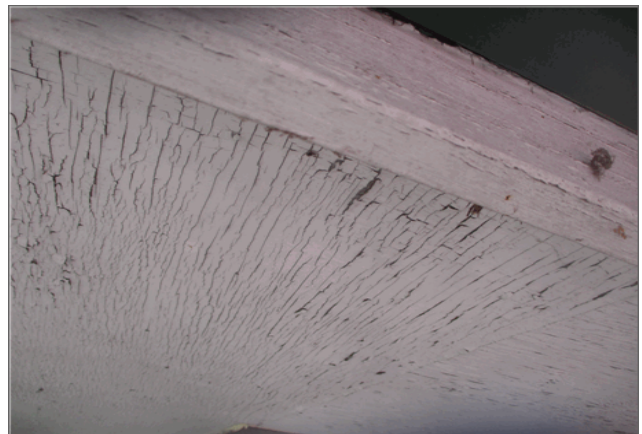
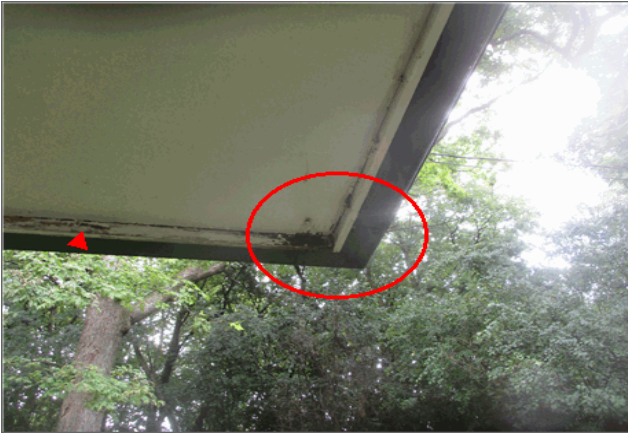
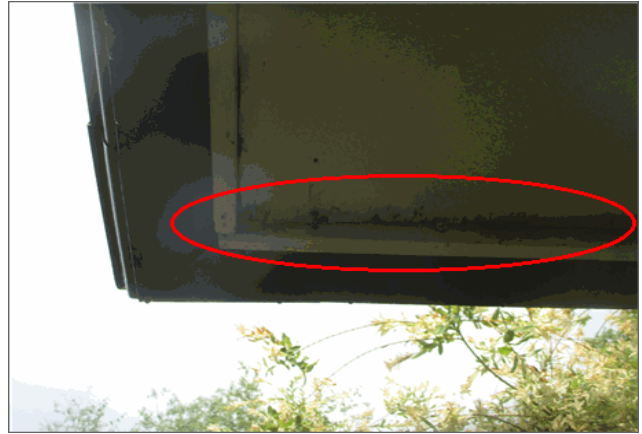
2.2.3 Exterior Wall & Trim Conditions

Brick appears serviceable. Wood rot, and peeling paint is present to soffits. Wood rot is at corners. Possibly due to leaky gutters at corners. Recommend to repair, or replace. Recommend siding specialist to further investigate.

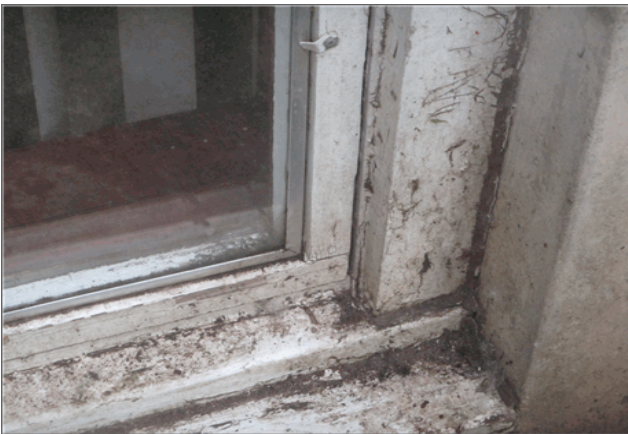
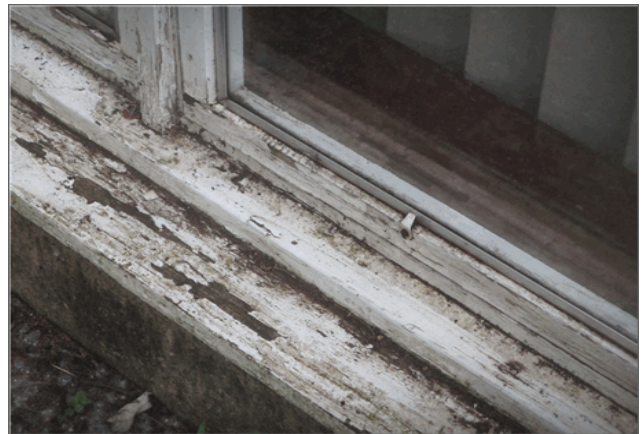
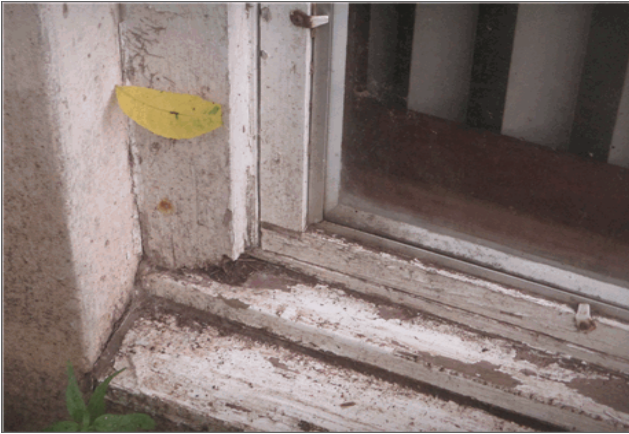
2.3.3 Window Conditions

NR Peeling paint, and wood rot is present to window trim, and sash on bottom north side windows. Recommend to repair, or replace.

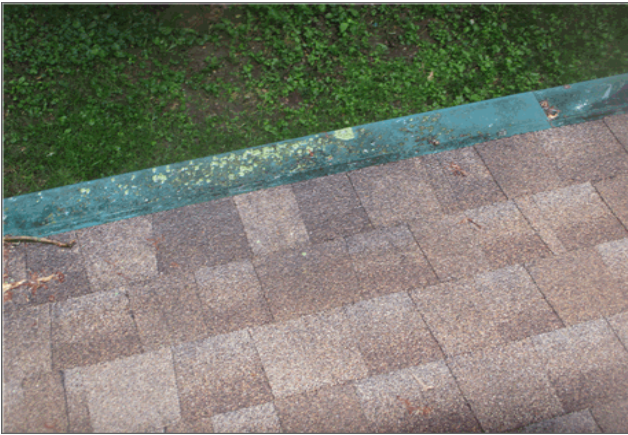
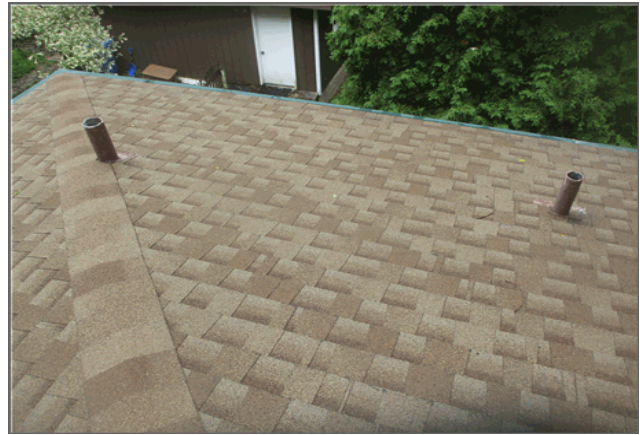
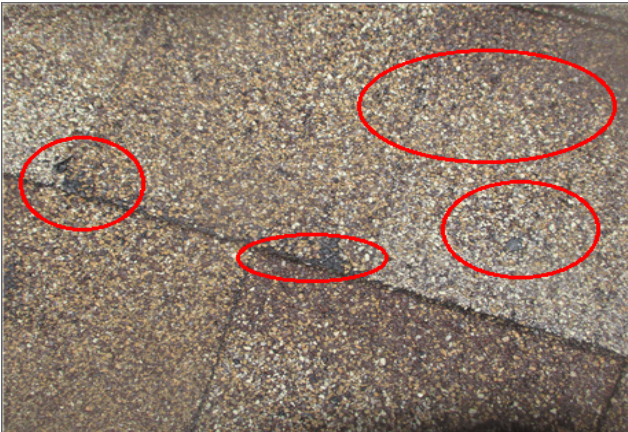
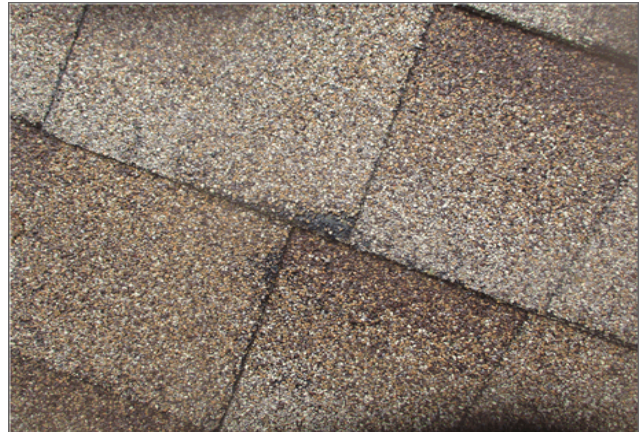
3.1.5 Roof Condition

Granule fading, and discoloration is present to shingles on roof. Approximate life on roof is about 5 years. Recommend roofing specialist to further investigate.

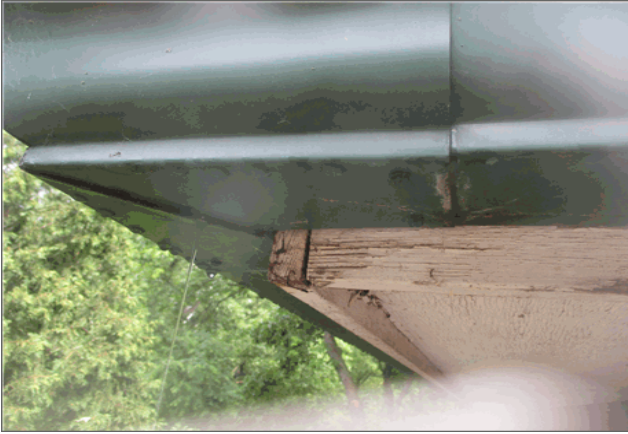
3.1.8 Gutter & Downspout Conditions

Gutters are leaking at corners causing wood rot to soffit, and fascias. Recommend roofing specialist to further investigate.

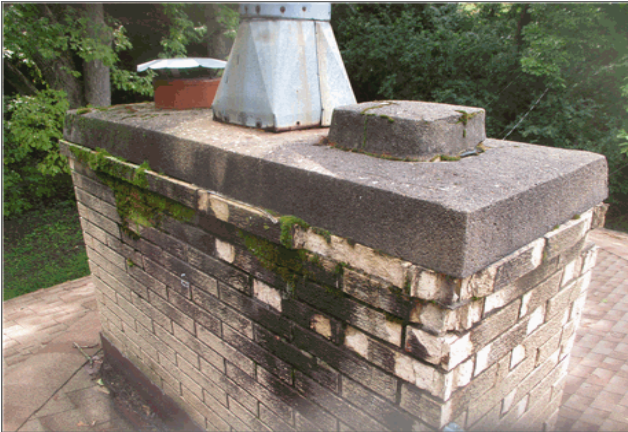
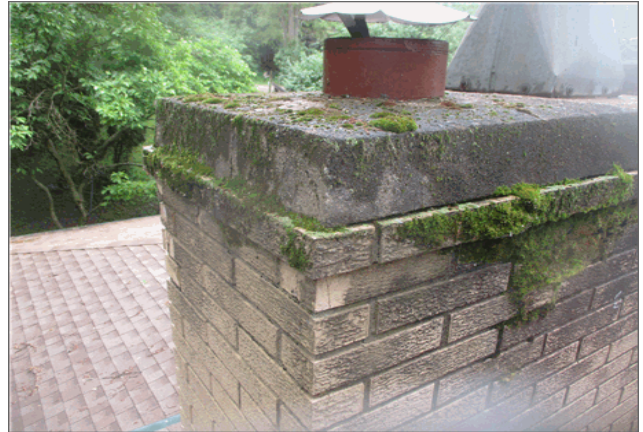
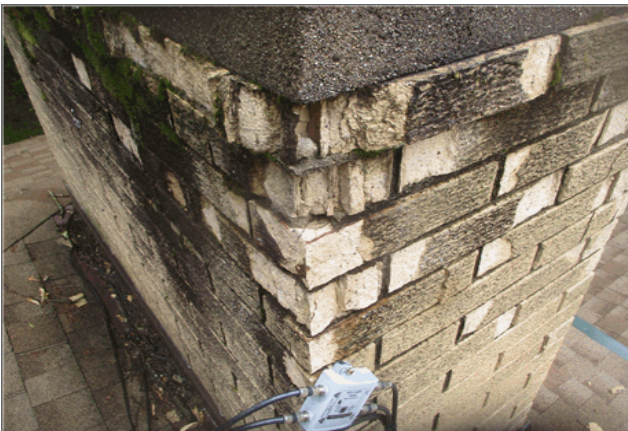
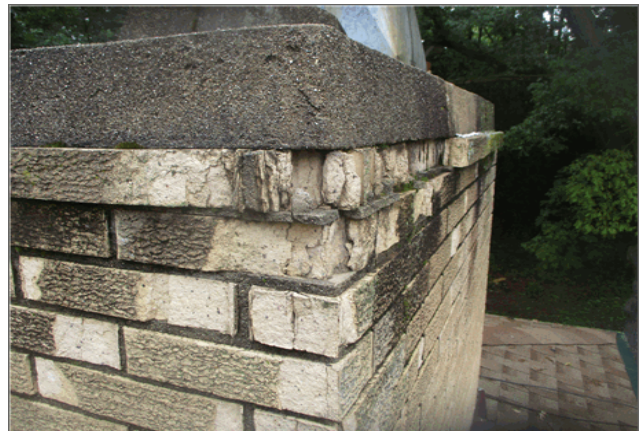
3.1.9 Chimney Conditions

Spalling of brick is present to chimney. Tuck pointing is needed to brick, and top of chimney. Recommend to remove algae. Recommend mason to further investigate.

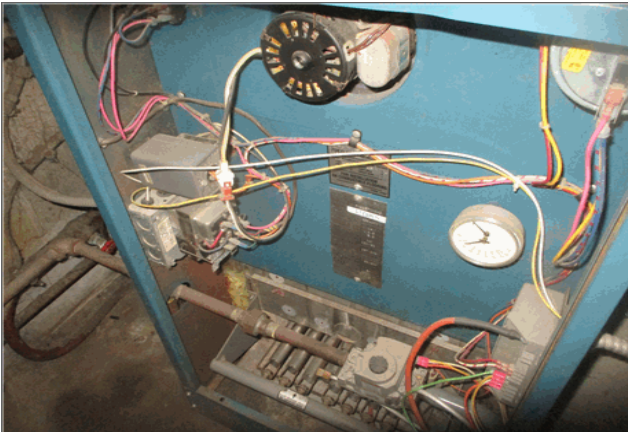
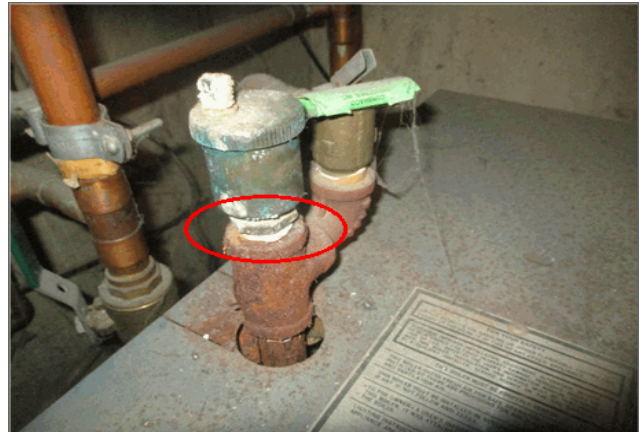
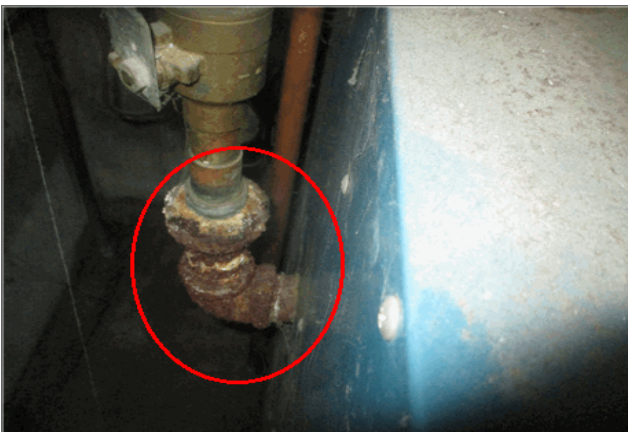
4.1.4 Unit Conditions

Corrosion to supply line near relief valve, and supply inlet. Recommend boiler technician to further investigate. Approximate life on boiler is about 20 years if properly maintained.

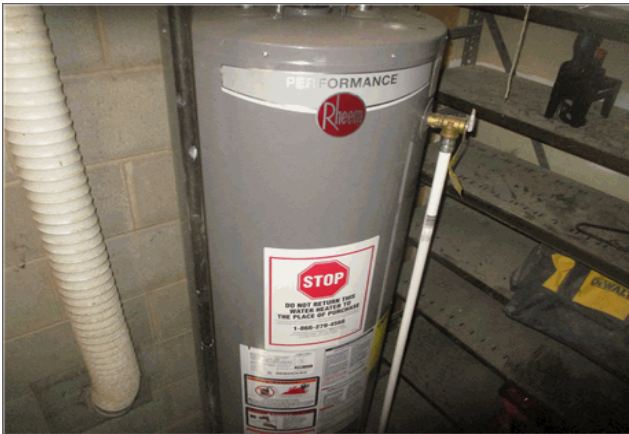
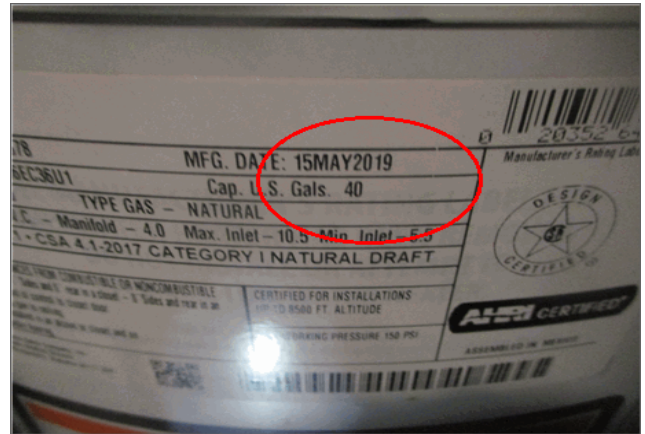
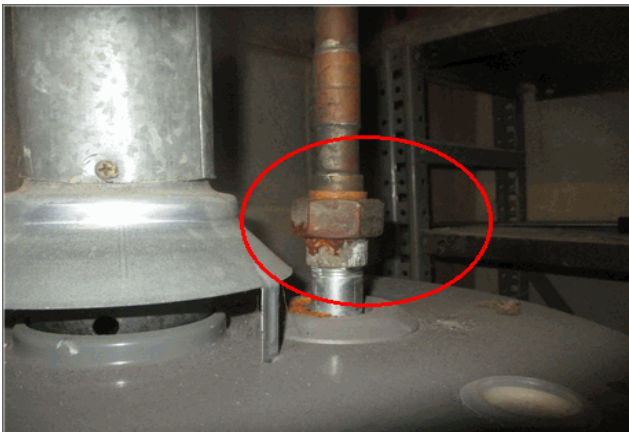
6.5.4 Water Heater Conditions

Slight rusting to supply connector. Recommend plumber to further investigate. Unit is a 2019. Approximate life on unit is about 8 years if properly maintained.

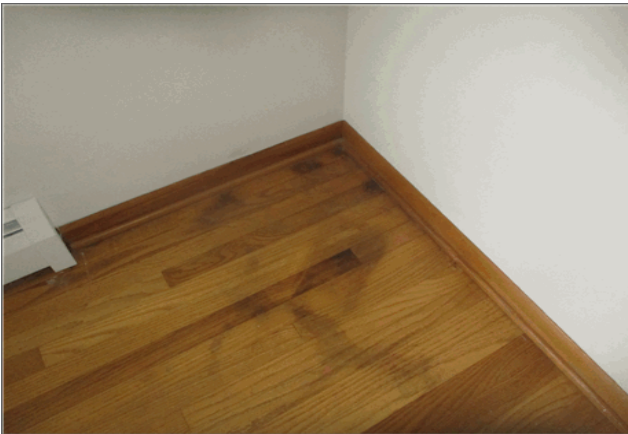
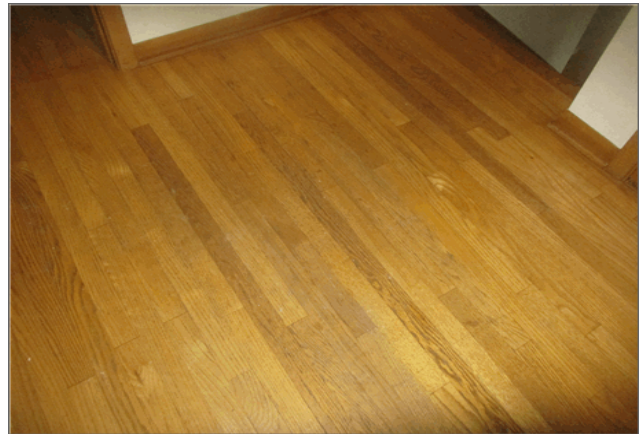
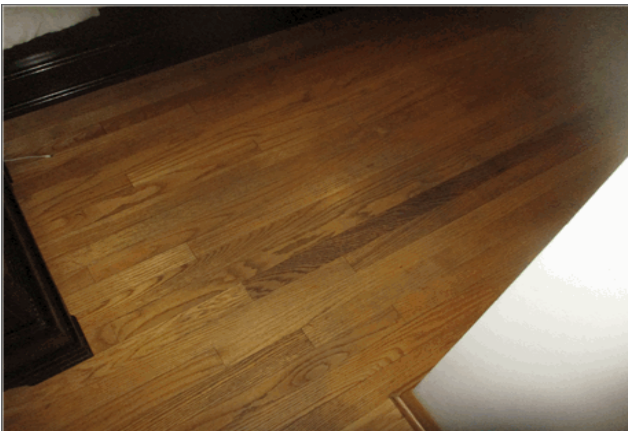
7.1.3 Floor Conditions

Hardwood floors have some stain, and stain fading. Possibly due to high traffic areas.

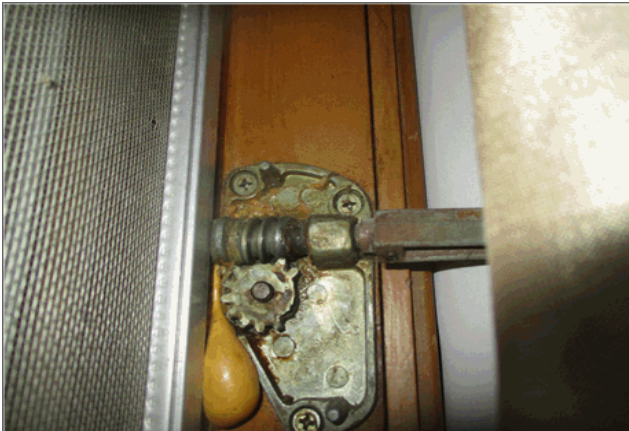
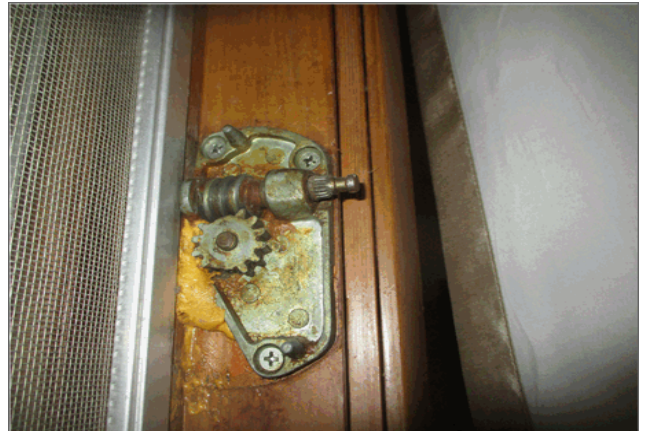
7.2.1 Interior Window Conditions

Gears to crank case for bedroom windows are broken, and making windows hard to open. Recommend to repair, or replace.

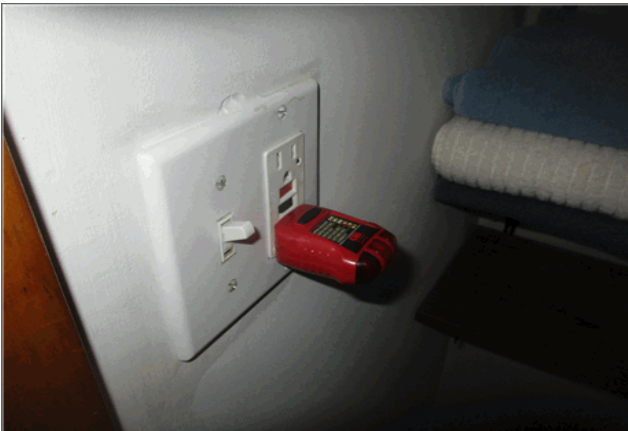
9.3.1 Electrical Conditions

No electrical power is present to GFCI outlet in basement bathroom. Recommend electrician to further investigate.

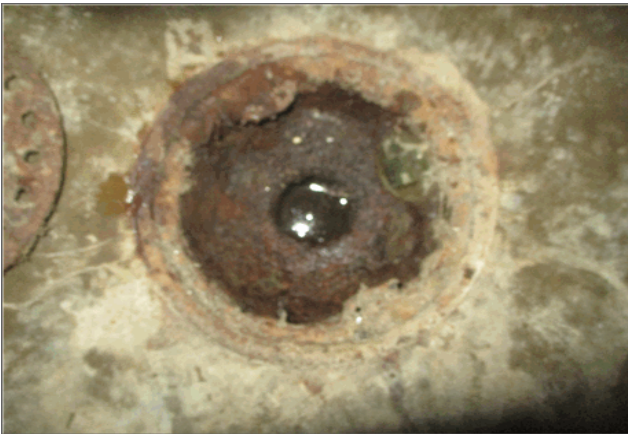
10.1.3 Floor Conditions

Floor drain in laundry room has a very slow drain. Recommend plumber to send camera through drain line to check for any obstruction. Recommend plumber to further investigate.

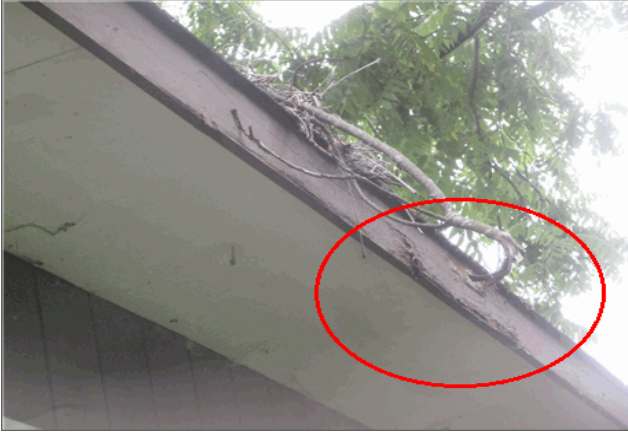
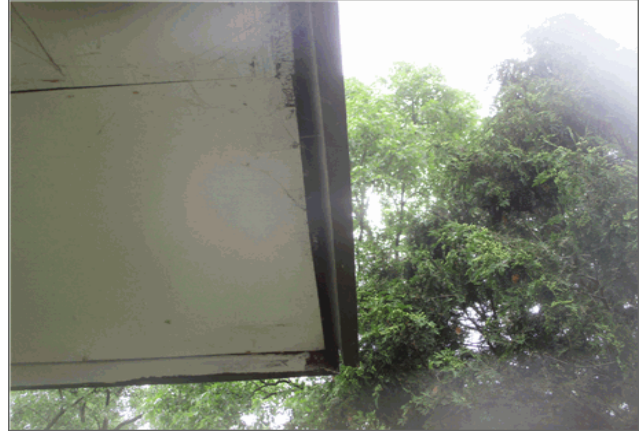
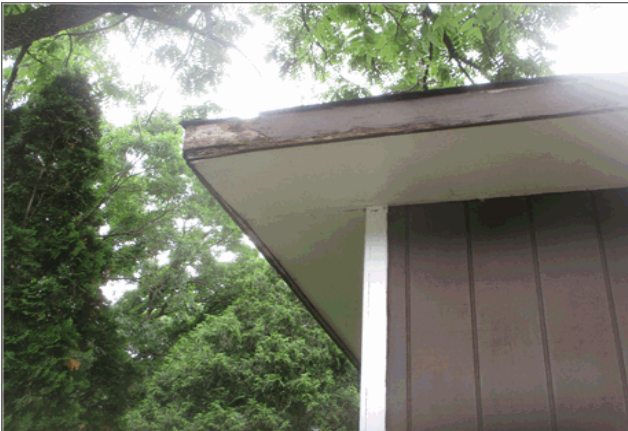
11.1.3 Roof Condition (if detached)

No gutters, and downspouts are not installed to roof. Possibly causing soffit and fascias to warp, and rot. Recommend roofing specialist to further investigate.

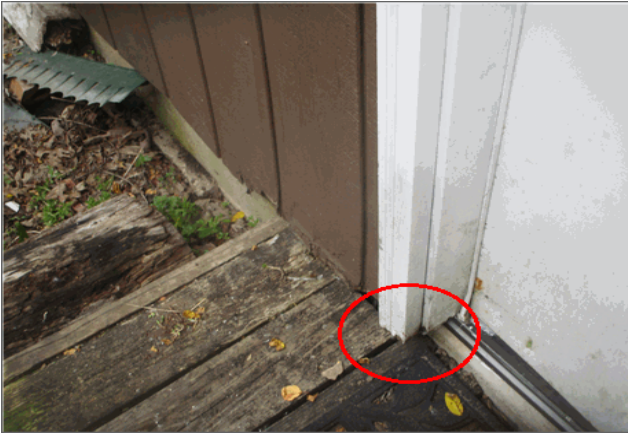
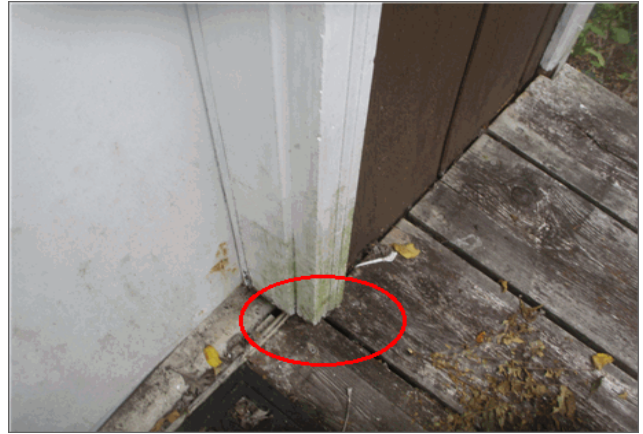
11.1.8 Door Conditions

Slight wood rot to bottom of door trim

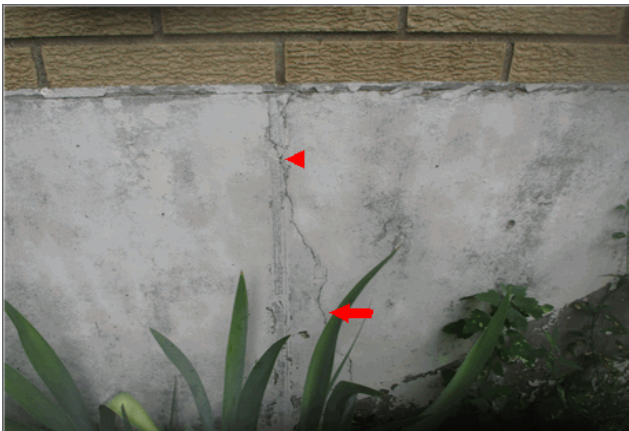
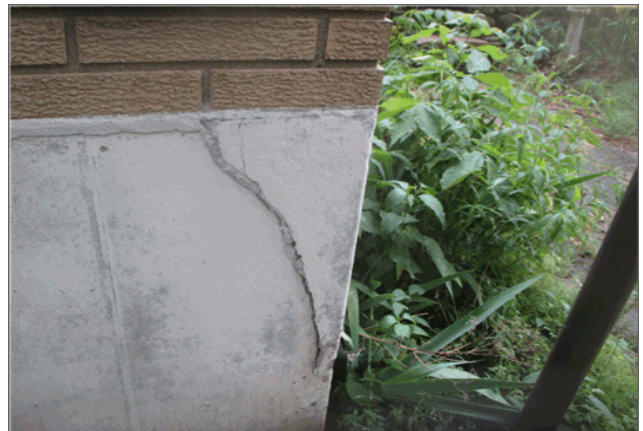
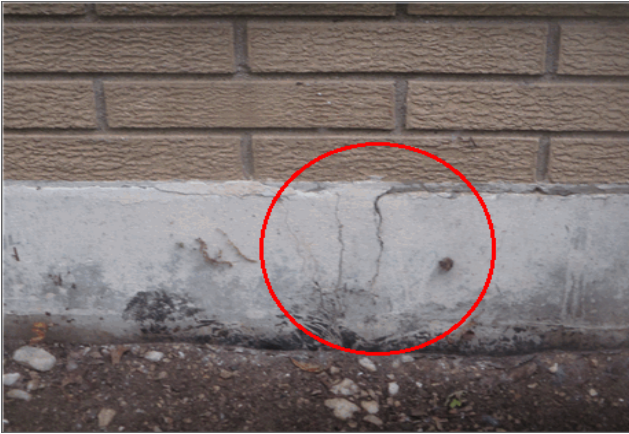
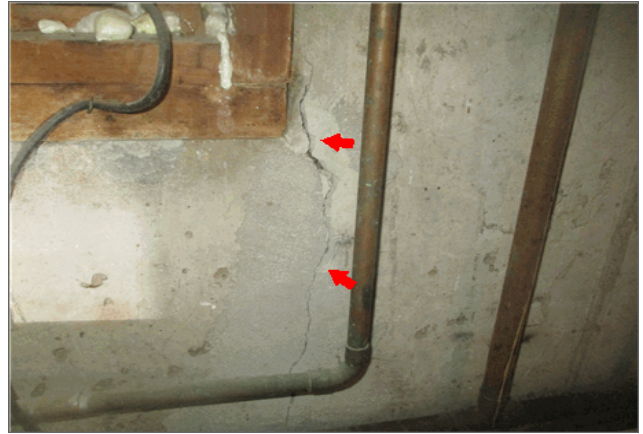
12.1.5 Foundation Condition

Foundation wall in basement is limited due to finished basement. Settlement cracking to foundation wall is visible to exterior, and in laundry room near window. Foundation in crawl space appears serviceable. Recommend foundation/waterproofing specialist to further investigate.
